JEWELL BROOK DAM SITE NO. 5
VT 00017

PHASE I INSPECTION REPORT
NATIONAL DAM INSPECTION PROGRAM

DEPARTMENT OF THE ARMY
NEW ENGLAND DIVISION, CORPS OF ENGINEERS
WALTHAM, MASS. 02154

APRIL 1980

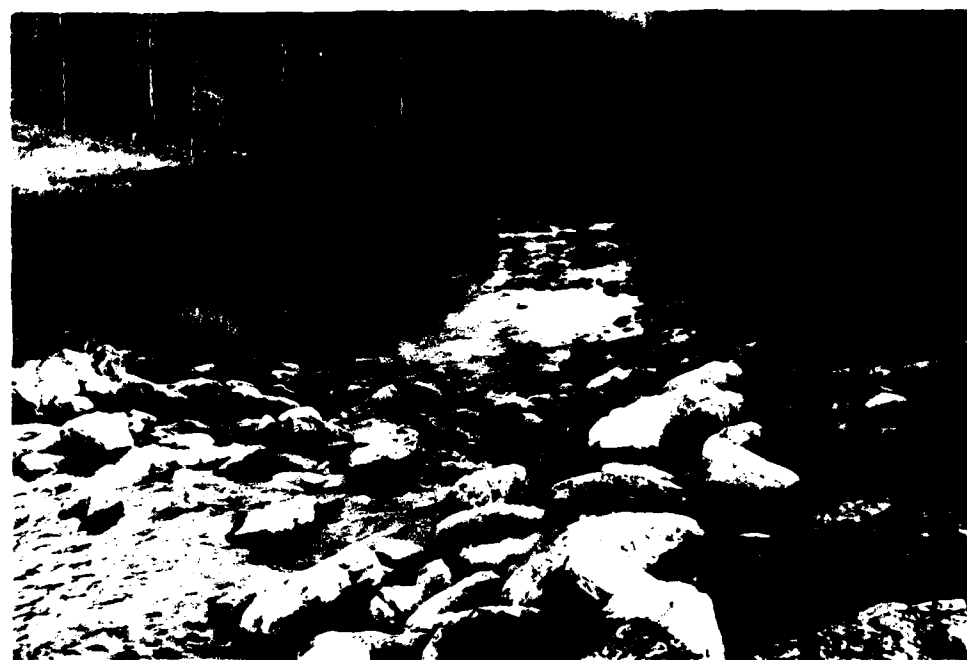
e. Downstream Channel. The downstream channel is a natural channel with cobbles and boulders along the channel floor (Photo 24). There were no loose rocks or trees overhanging the channel.

#24 DOWNSTREAM CHANNEL
